Picayune Strand Restoration Project Restored Footprint Exotics Mapping and Control Coordination–Annual Summary Effectiveness Assessment Report (June 2013)

Work Order No. 4600001953-WO3

June 15, 2013

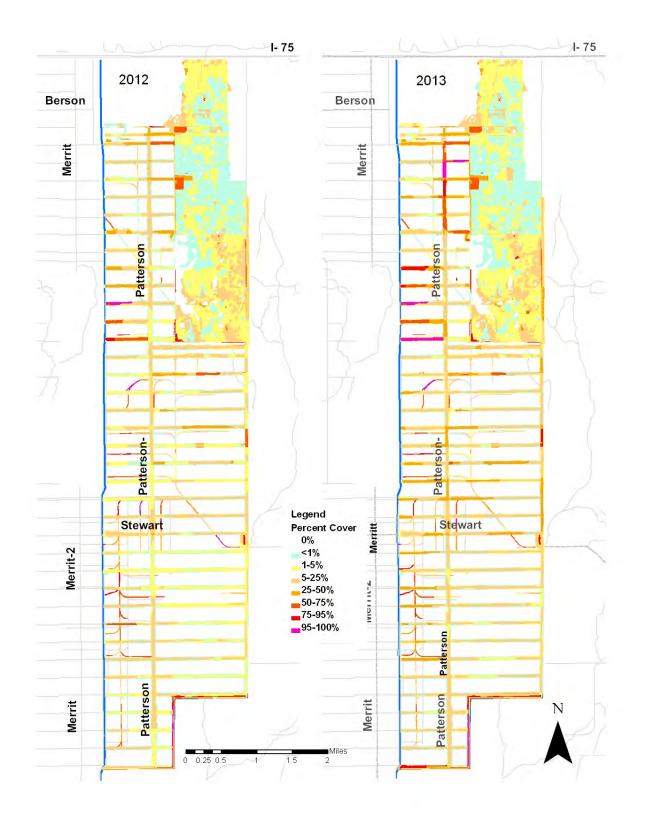
*Figure 12: Total Cover by Exotic and Nuisance Species in Prairie Canal Phase Footprints and Demolition Sites (2012-2013)*

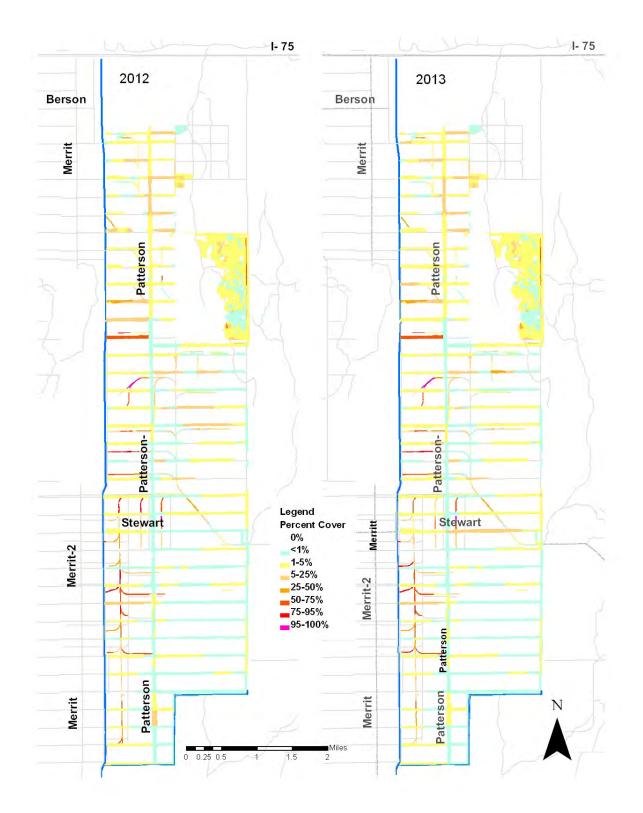
Figure 14: Total Cover by FLEPPC II Exotic and Nuisance Species in Prairie Canal Phase Footprints and Demolition Sites (2011-2012)

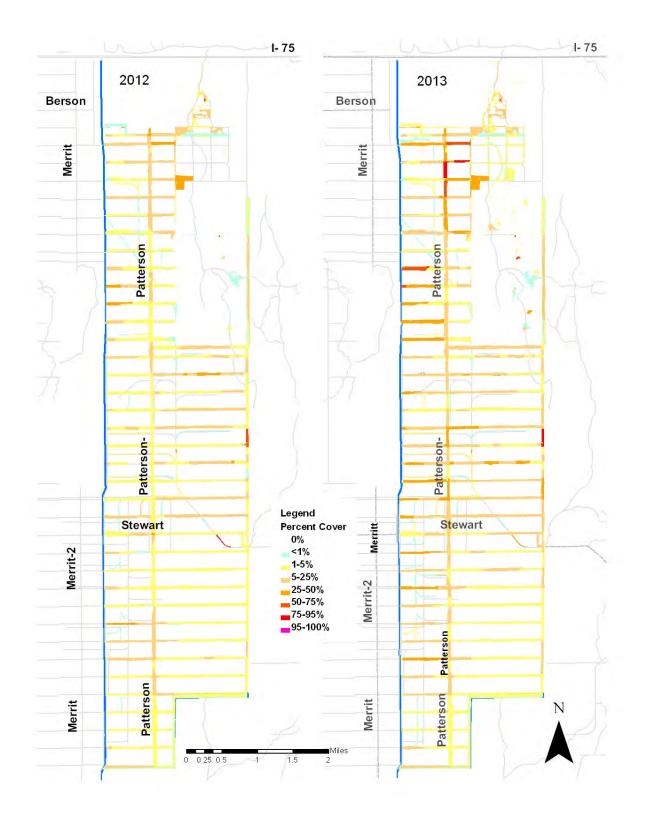
*Figure 15: Total Cover by Non-FLEPPC Exotic and Nuisance Species in Prairie Canal Phase Footprints and Demolition Sites (2011-2012)*

Total acres infested by non-listed invasive exotics had increased from 115 acres in 2012 to 215 acres in 2013 (Table 13) (Figure 15). This increasing trend was also observed and discussed last year (ERM 2012). The increase is probably due to increased light availability at the actual demolition sites where we have treated Brazilian pepper (ERM 2011), as well as increased space available where other more aggressive grasses have been treated. Actual cover was 15 acres (0.9%) in 2012 and 21 acres (1.2%) in 2013 (Table 14). The majority of this cover, as mentioned in previous reports (ERM 2012), is smutgrass. Cover by this exotic was largely restricted to the old home sites, although it is also scattered around trails throughout the demolition site buffers.

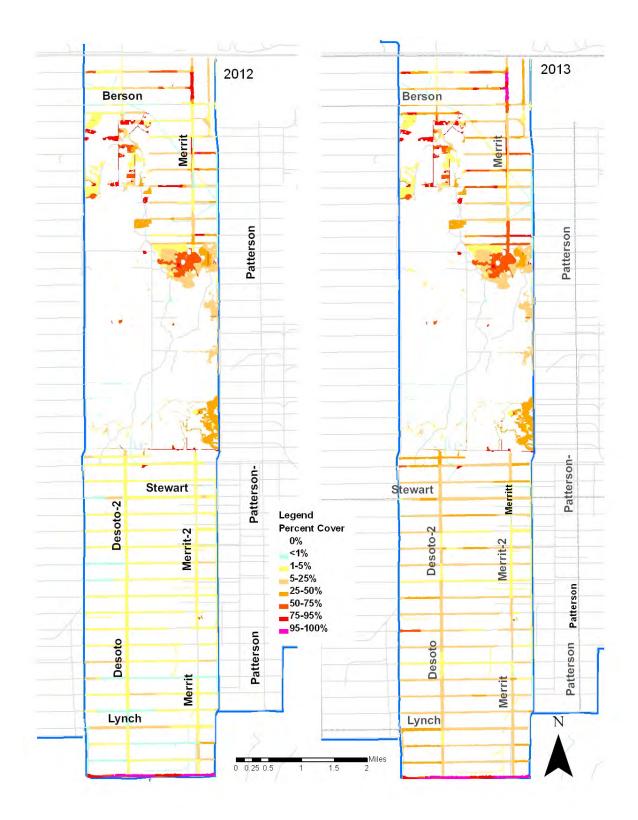
*Figure 19: Total Cover by Non-FLEPPC Exotic and Nuisance Species in Merritt Canal Phase Footprints and Demolition Sites (2011-2012)*
